September 19, 2013

Mersen Gonzales has completed repairs and returned exchanger as follows. Unit was received with 50 plus plugged tubes and severe gaskets head leakage on the fixed end. It was found that the tubesheet gasket face was deteriorated or flaked off causing gasket failures. Choice made to repair/machine both tubesheets to restore gasket surfaces. After cleaning tubes, a good test was then put on exchanger. 2 tubes were found leaking but the fixed tubesheet right at the gasket area was severely bleeding. This could have been the leak instead of the gasket this retightening did not help while at plant. For repairs we performed the following.

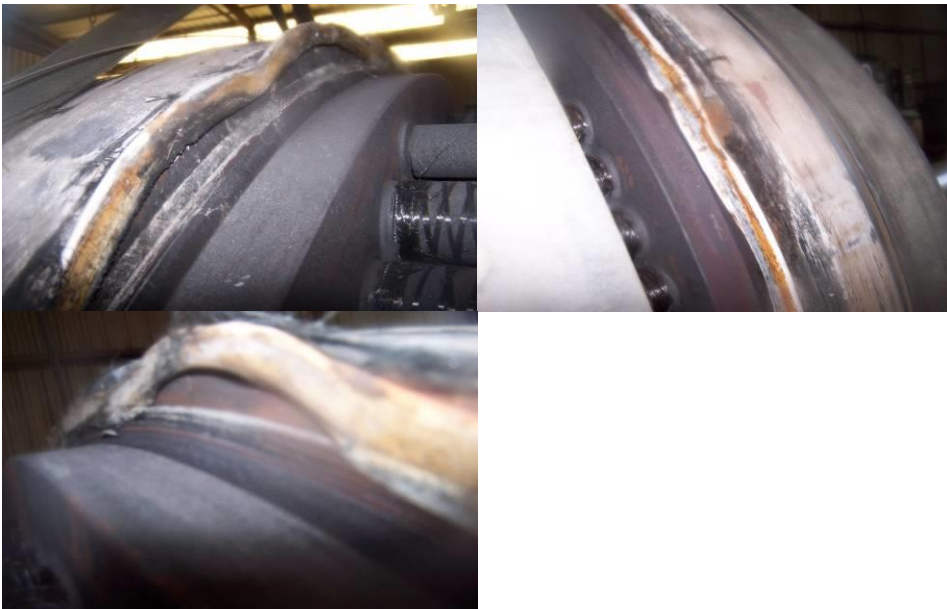
Picture 1 – 3 – Blown gasket on fixed end.

- All graphite faces were repaired and machined
- Both tubesheets were hot dipped to prevent the graphite from bleeding.
- Unit was assembled with all new gaskets and packing.
- Exchanger hydro-tested ok at 100 psi and was shipped with 20 psi to PCS.

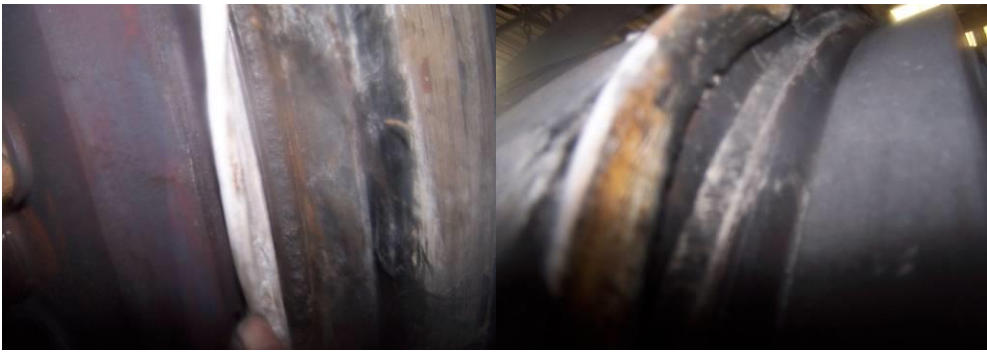
Picture 4 & 5 – Gasket face is sheared off.

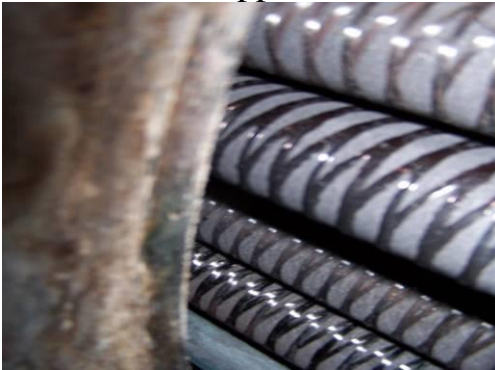
Picture 6 – Wrapped tubes in unit.

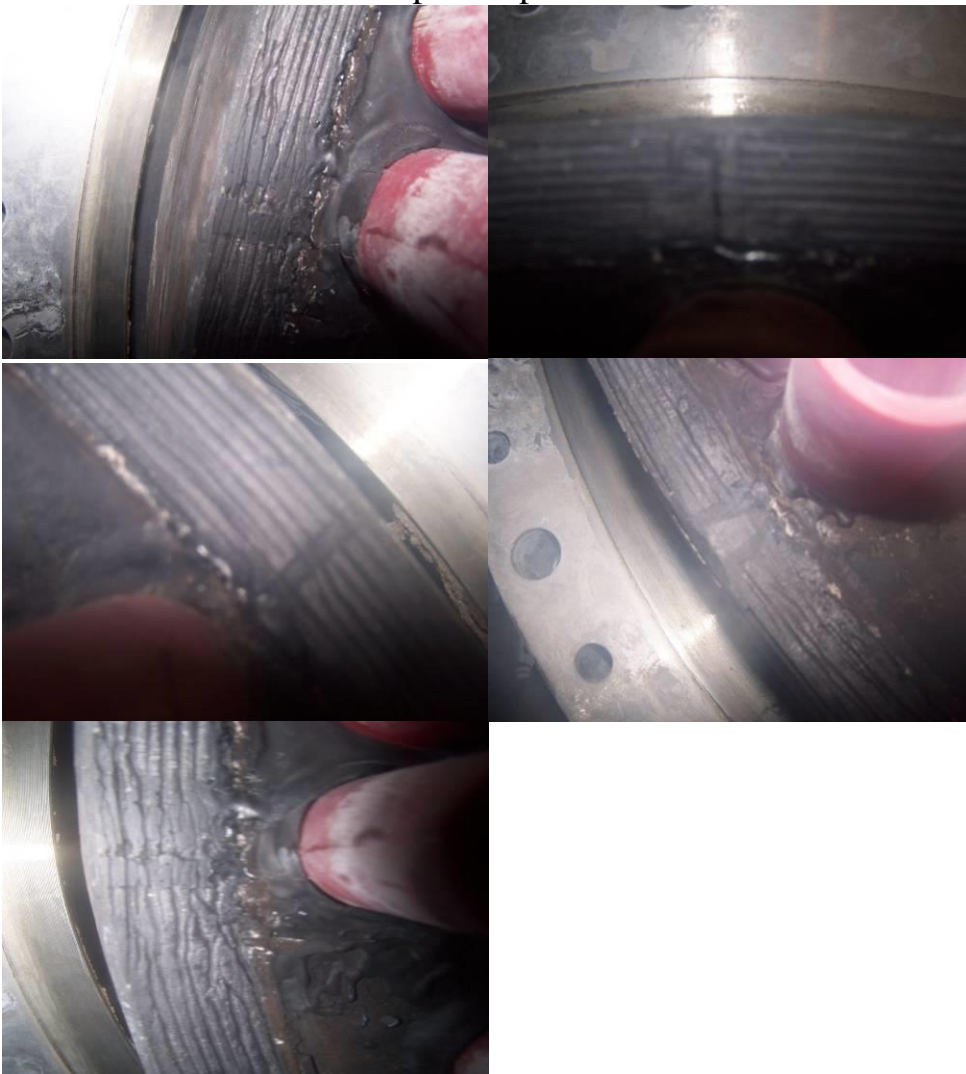
Picture 7 – 11 – Numerous poor repairs to tubesheet

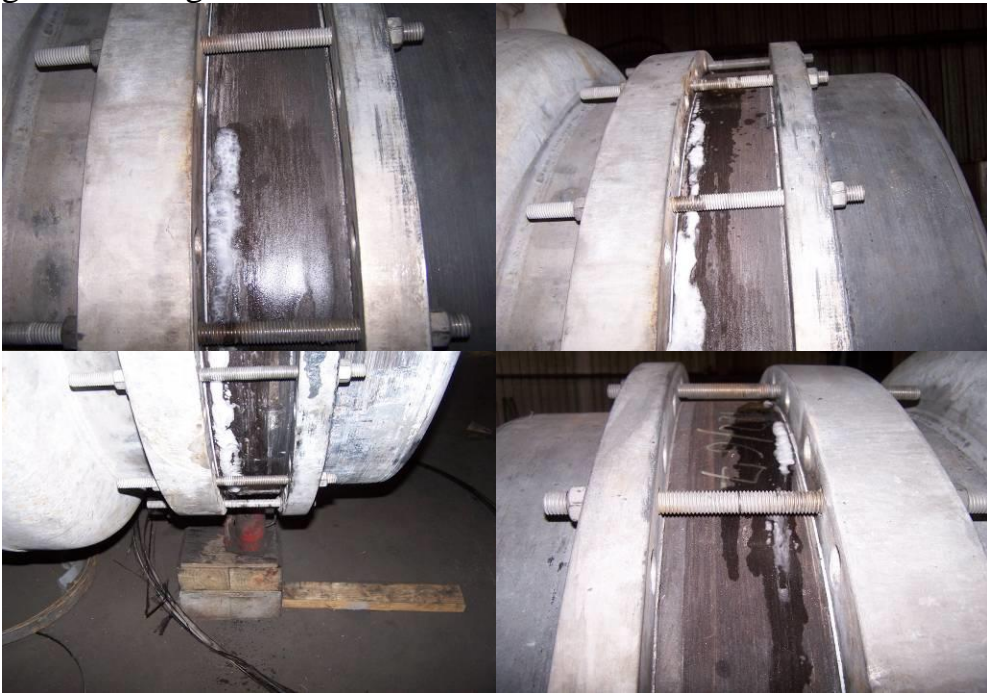
Picture 12 – 15 – Bleeding areas at gasket area found to be cause of the gasket leakages.

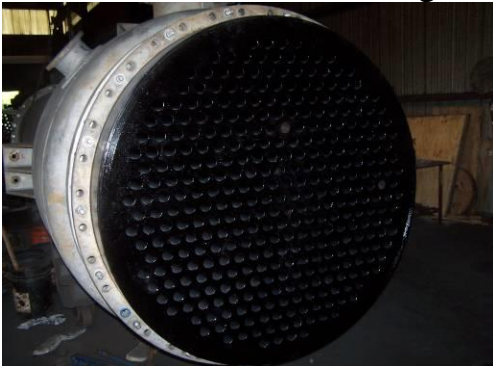
Picture 16 – Tubesheet being coated/repaired.

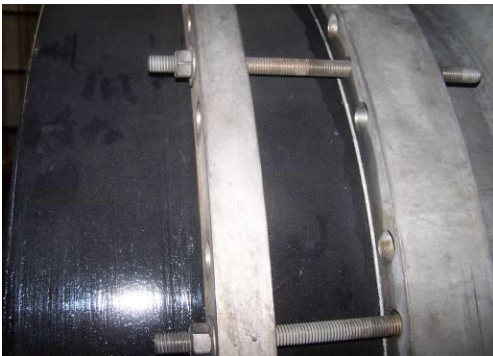
Picture 17 – No leaks in tubesheet upon testing.

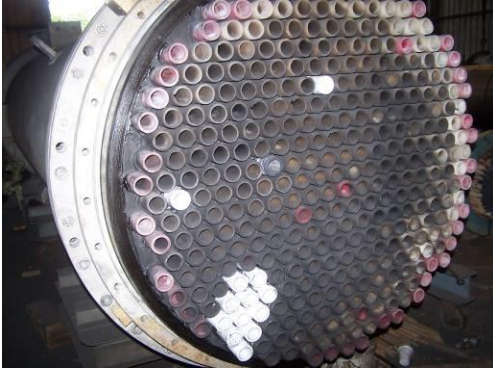
Picture 18 – Repaired floating tubesheet with replaced white inserts.

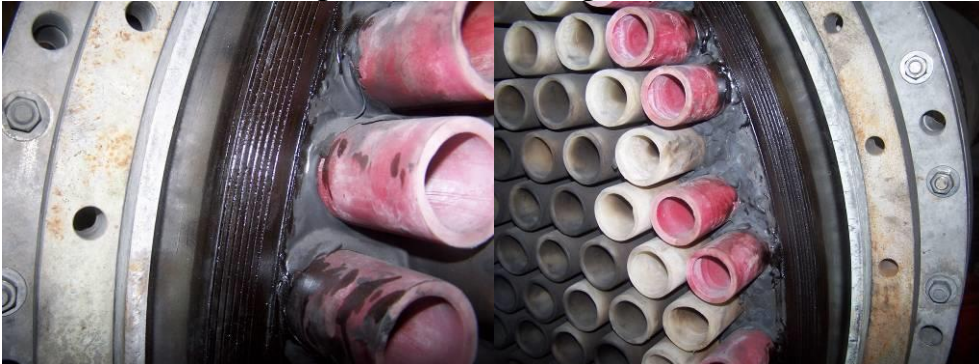
Picture 20 & 21 – Repaired/Machined gasket surface.
